# Amazon Kindle Paperwhite 7th Generation Repairability Assessment

Amazon Kindle Paperwhite repairability assessment performed on January 5, 2017.

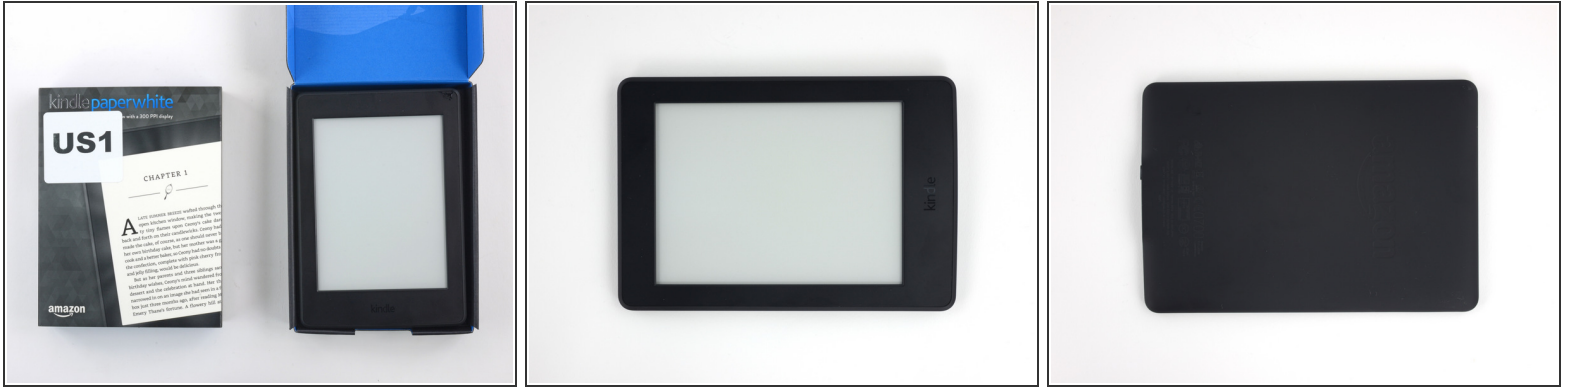
## Step 1 — Amazon Kindle Paperwhite 7th Generation Repairability Assessment

- Front and rear reference shot.

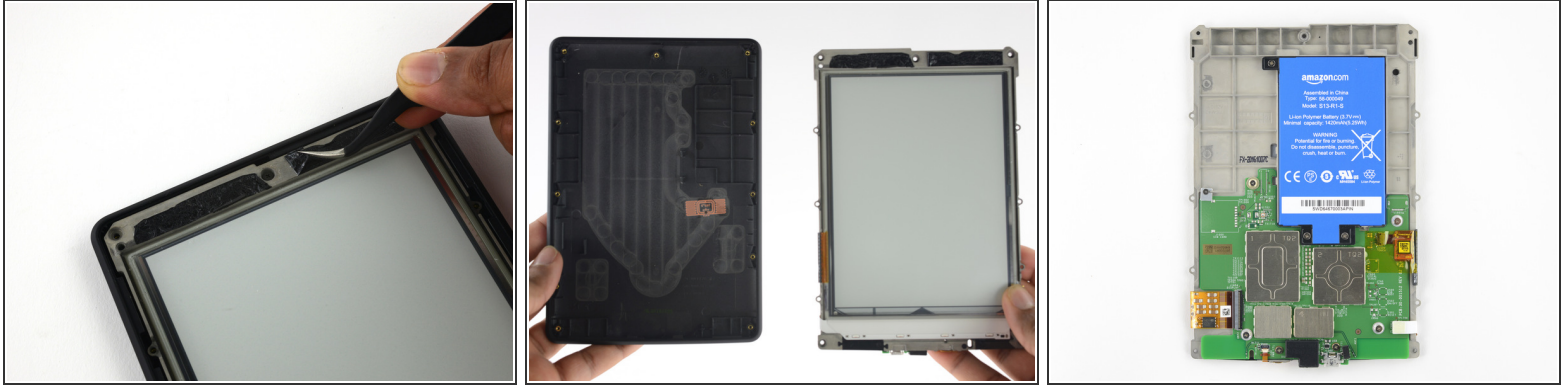
## Step 3

- There are 11 Phillips screws holding the midframe to the rear case. One of those screws is hidden underneath tape.
- Once the screws are out the midframe easily separates from the rear case.
- The battery and motherboard are connected to the rear case.

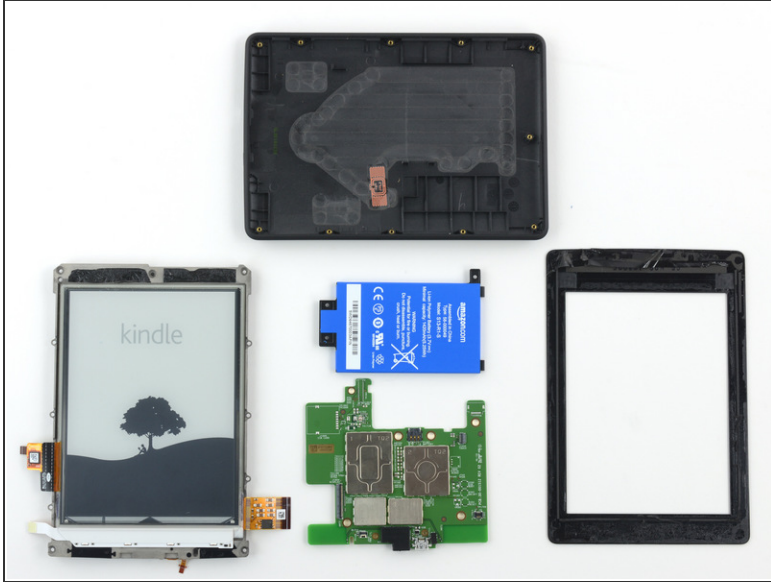
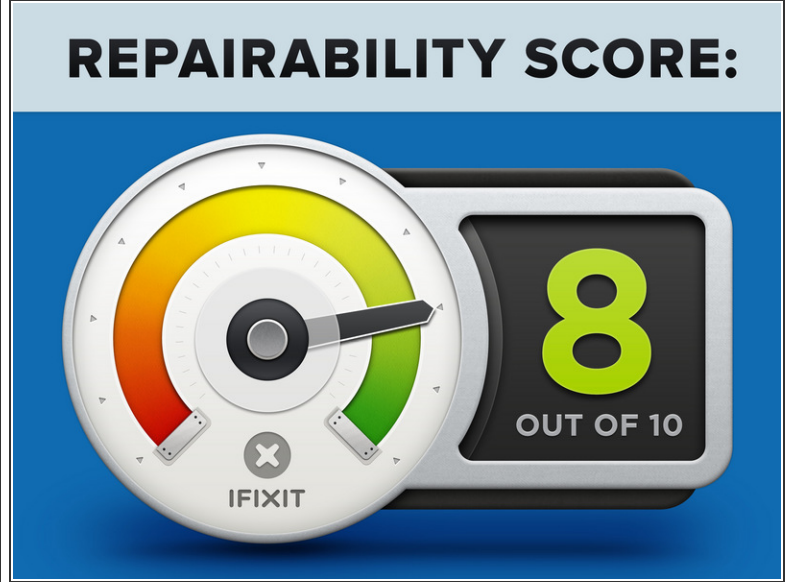
## Step 6

- The Amazon Kindle Paperwhite earns an **8 out of 10** on our repairability scale (10 is the easiest to repair):
  - The battery was very easy to remove.
  - All screws were Phillips #00 screws.
  - All components likely needing replacement were modular, except for the USB port.
  - Thin layer of adhesive that needed to be broken in order to remove the bezel and access the internal components.
  - Manufacturer does not provide user-accessible repair documentation.
